*2868391 PROCESSING OPERATIONS CONTROL **OMI PLANNING SHEET** Wad Number SITE Elem CD End Item S6444-J01-R01 LCC ٧ 10X0FLT: 029 DATE: 02/20/2001 TIME: 07:57:54 Title: Sub Element/Zone SSV ICE AND DEBRIS ASSESSMENT 30 Project Work Order No. SFOC Safety Local Copy WC N/ 120 Yes No USA Firing Room Copy **Authorizing Document** Material & Equipment: MICR Reg'd FEB 15 '01 ORB329-281(ADD) Yes No Yes ☐ No X Yes n APR 101 ☐ No PERFORM THE FOLLOWING: Pre-Ops Setups Task Number Operation Number Seq Steps Task <u>Seq</u> Steps TACCS USA VM 044 **OPS Support** Task Operation Task Operation Seg Steps <u>Seq</u> Steps **Operating Instructions** <u>Task</u> Seq Steps Task <u>Seq</u> Steps 010 090 100 120 130 140 150 Post Ops USA VM 005 **Appendices** Task Number Seg Steps Task N/A USA VM 075 Subtask WAD's N/A Ext QC Closure Date Page 126 USA FEB 15 101 LISA RUTKOWSKI APR 3 109 0746 lor_ 1

SSV ICE AND DEBRIS ASSESSMENT

STS-102

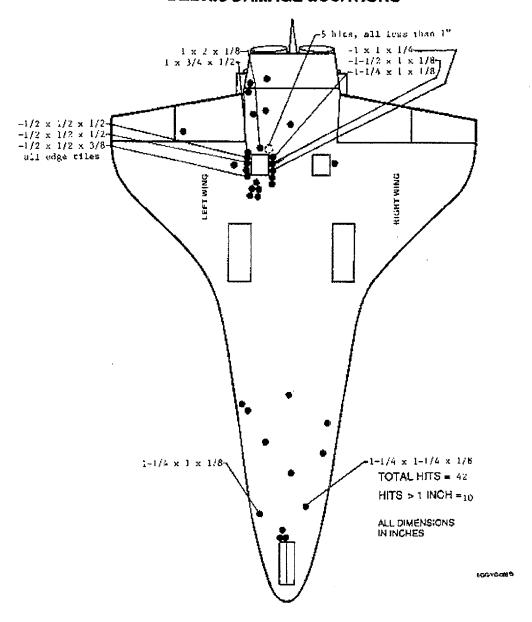
DEBRIS DAMAGE LOCATIONS

Approximately 12 damage sites (with two larger than 1-inch in length) were located in the area from the nose landing gear to the main landing gear wheel wells. The majority of the hits were around the LH2 umbilical area (22 hits). Most of these damage sites around the ET/ORB umbilical were most likely caused by pieces of the umbilical purge barrier flailing in the airstream and contacting tiles before pulling loose and falling aft. The ET TPS venting modifications continue to have a reducing effect on the quantity and size of the damage sites.

The largest lower surface tile damage site, located aft of the LH2 umbilical, measured 1-inch long by 2-inches wide by 0.125-inches deep. A combination of umbilical ice and/or umbilical purge barrier material could have been the cause of this damage site.

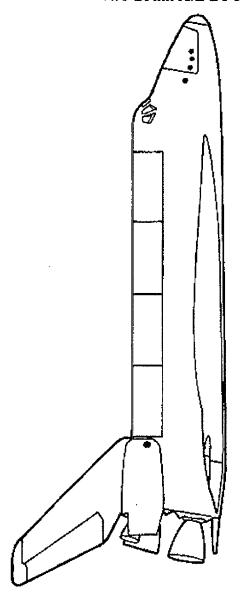
DEBRIS DAMAGE LOCATIONS

TOTAL HITS = 5 HITS > 1 INCH = 0
